Rev.:	Int.:	Date:	Comment		
Customer.:					
Subjekt.: Extension tube f. Ø101,6 - V500					
Date.: 19-10-2021		Production no.:		Scale.: 1:10	
Order no.:		Calculation:		Int.: SP/MRF	
Drawing. No.: ET-Ø101 V500				Note.:	
This drawing is our property and must not be copied, transferred or in any way used by a third party without our written permission

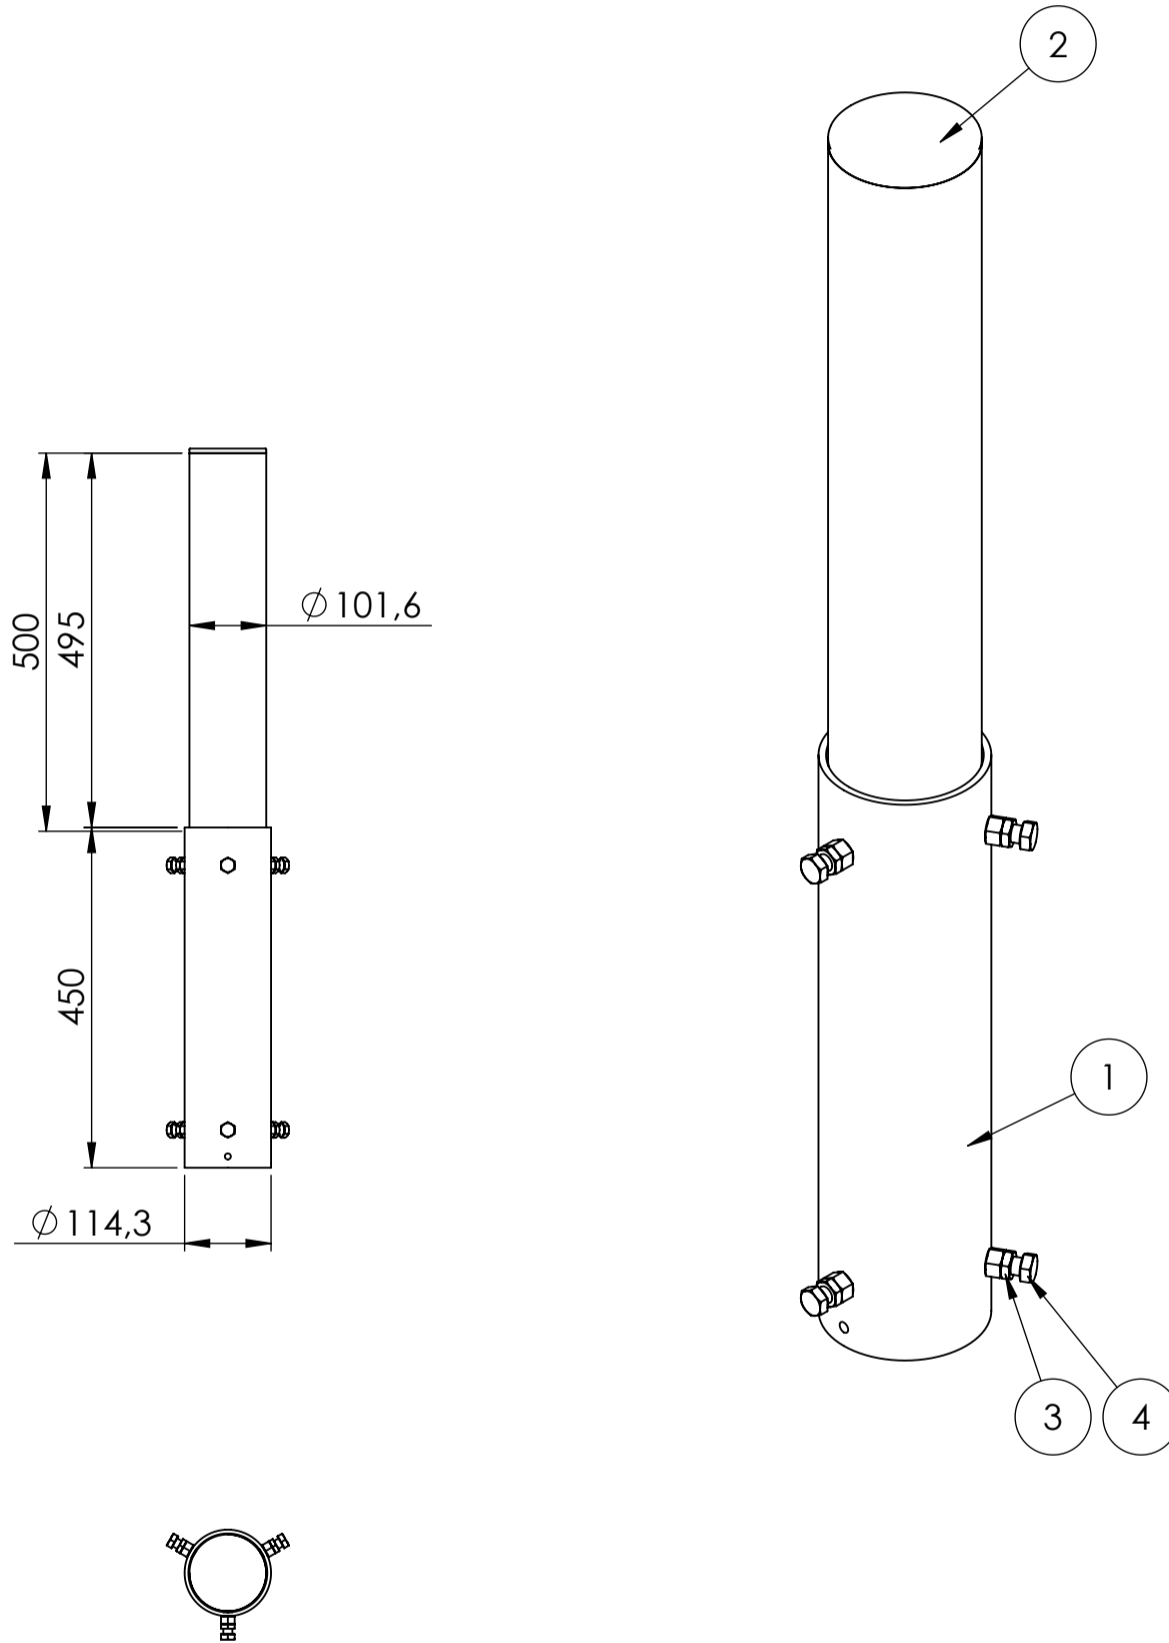
1st nut should be spanned to a tight condition.
 2nd nut should be brought at least to a snug-tight condition, with special care being given to avoid over-tightening.
 Nut-marking should be made acc. to figure after torque.

Visual inspection of bolt torque and any loose items is made 1 year after installation, and afterwards every 5th year.
 Check if the marking from bolt torque is still straight.
 Check if the corrosion protection system is satisfactory.
 Any findings must be repaired as soon as possible.
